NACA RM E55A21

ENGINE PERFORMANCE OF PRECISION-FORGED, ELECTROPOLISHED  
AND MACHINED BLADES OF NIMONIC 80 AND 80A ALLOYS

By Paul F. Sikora and James R. Johnston

Lewis Flight Propulsion Laboratory  
Cleveland, Ohio

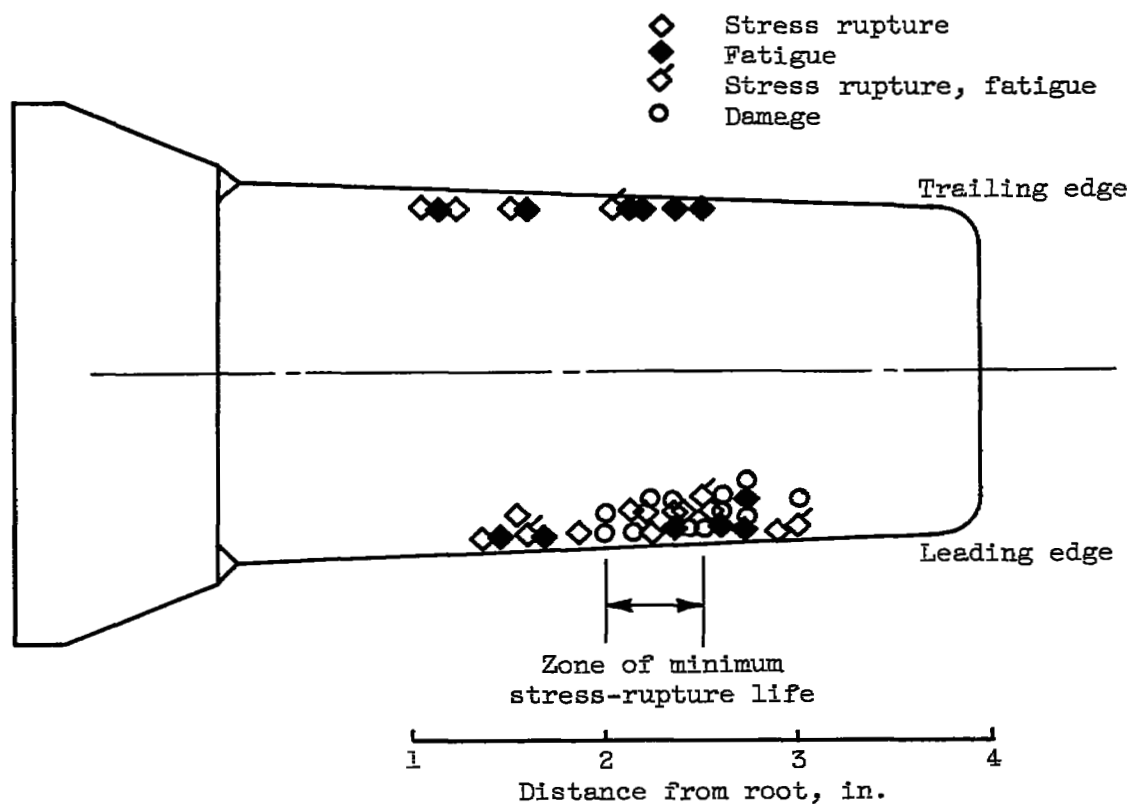
Figure 6. - Location of blade-failure origins and mechanism of blade failures.

The location of failure origin and the mechanism of blade failure are shown in figure 6. Exclusive of the damage failures, it was determined that:

(1) A total of 45 percent of the blades failed by fatigue, 17 percent failed by stress rupture followed by fatigue, and 38 percent failed by stress rupture.

(2) Of all the blade failures, 65 percent originated at the leading edge.

(3) Of the blade failures originating at the leading edge, 42 percent were by stress rupture, 37 percent by fatigue, and 16 percent by stress rupture followed by fatigue.

(4) Of the blade failures originating at the trailing edge, 60 percent were by fatigue, 20 percent by stress rupture followed by fatigue, and 20 percent by stress rupture.
